## Remediation of Oskarshamn Hamn

Bart Van Renterghem – Envisan NV

Past, present and future...

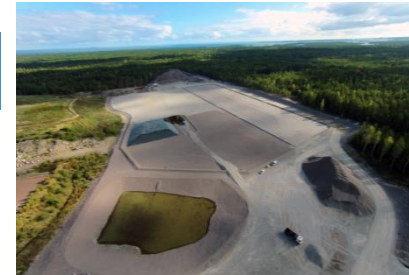
Mono landfill

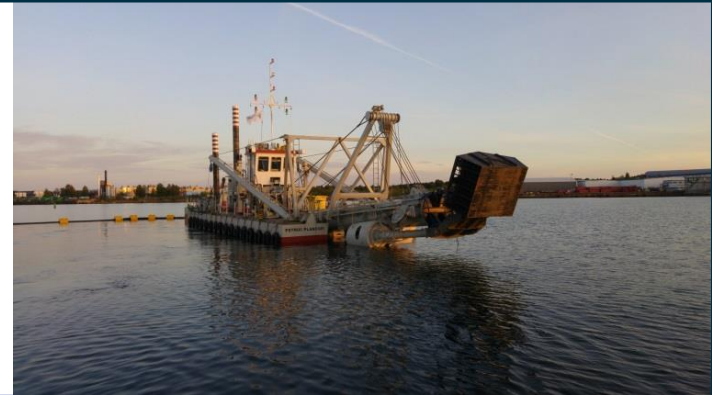
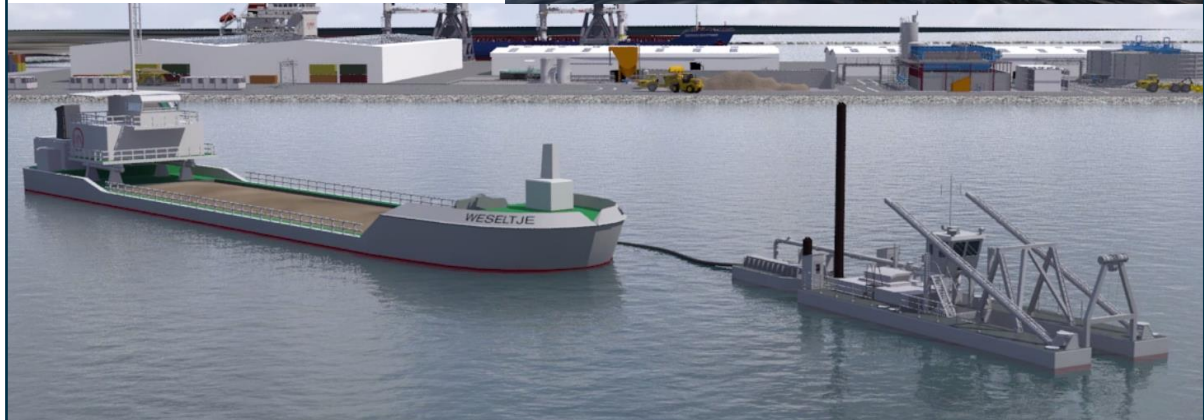
## Hydraulic dredging

- ca. 320,000 in situ m<sup>3</sup>
- Layers from 0,1 to 5 m
- Target of min 10 % DS

## Mechanical dredging

- ca. 70,000 in situ m<sup>3</sup>

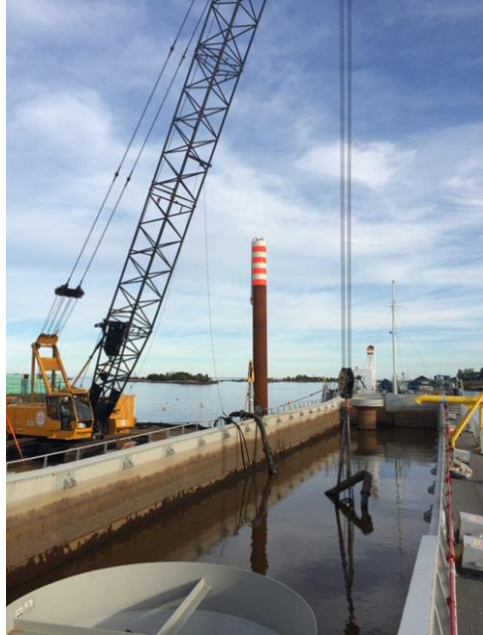
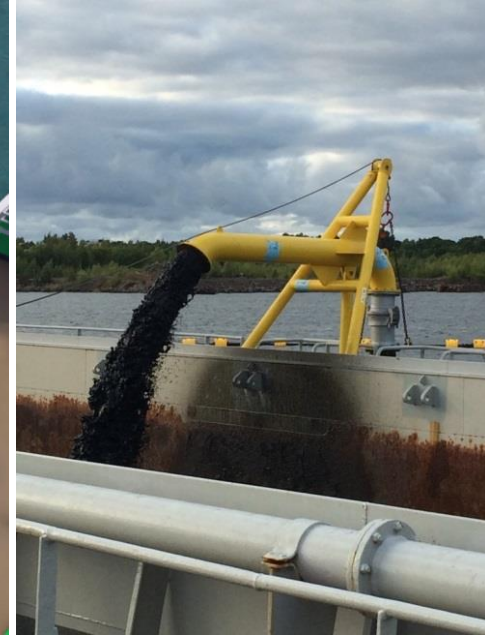
ca 1000 m<sup>3</sup>/day

ca 500 m<sup>3</sup>/day

Sediment reception & sieving

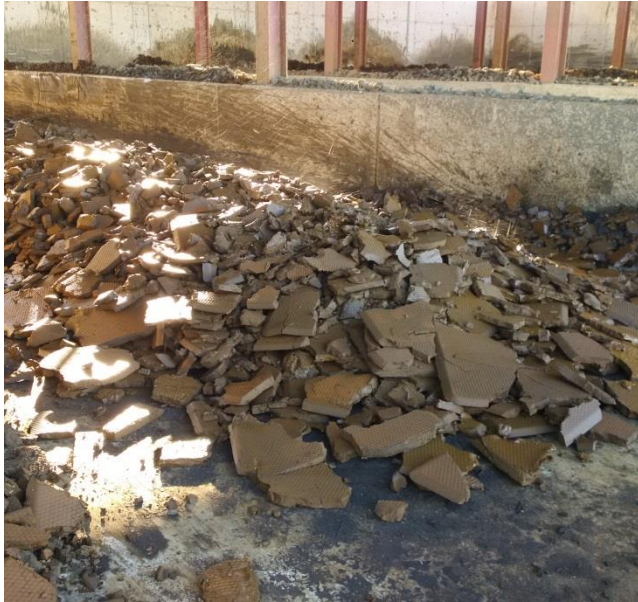
Dewatering from 10 % DS to > 40 % DS
